Date: 21 May 2025

TECH TOOL RELEASE NOTES

Version 2.8.330

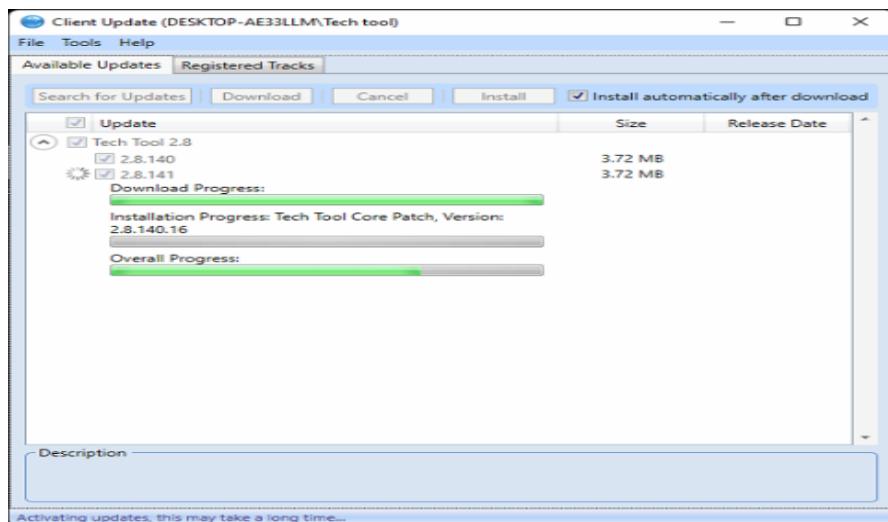
Issue-1: Tech Tool installation progress bar is frozen during Client Update.

Cause: Under Investigation.

Suggestion: Restart computer if the progress bar is frozen.

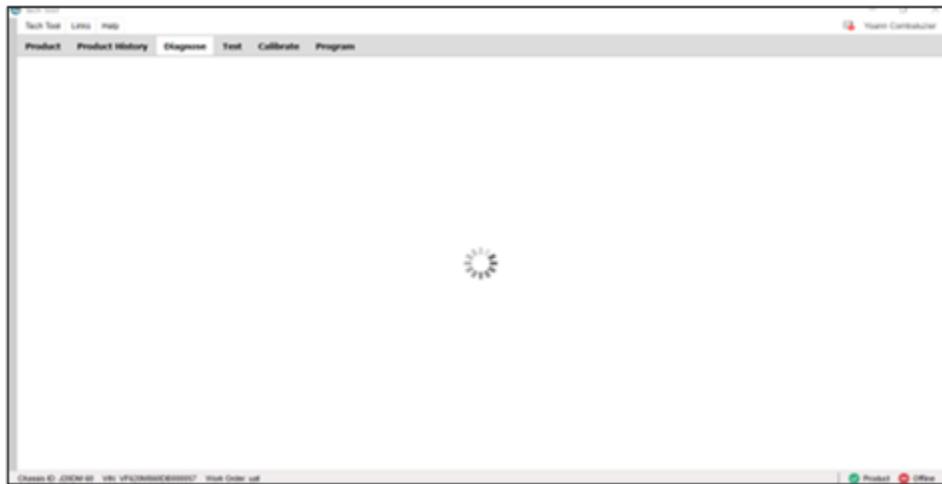
Issue-2: While switching between the tabs, Tech Tool might be frozen.

Cause: Under Investigation.

Suggestion: Kindly follow the below steps:

1. Ensure that there is a stable network as shown in the icon

2. Restart Tech Tool.
3. If not able to recover, restart the computer.
