TECH TOOL RELEASE NOTES

Version 2.8.370

Volvo Group

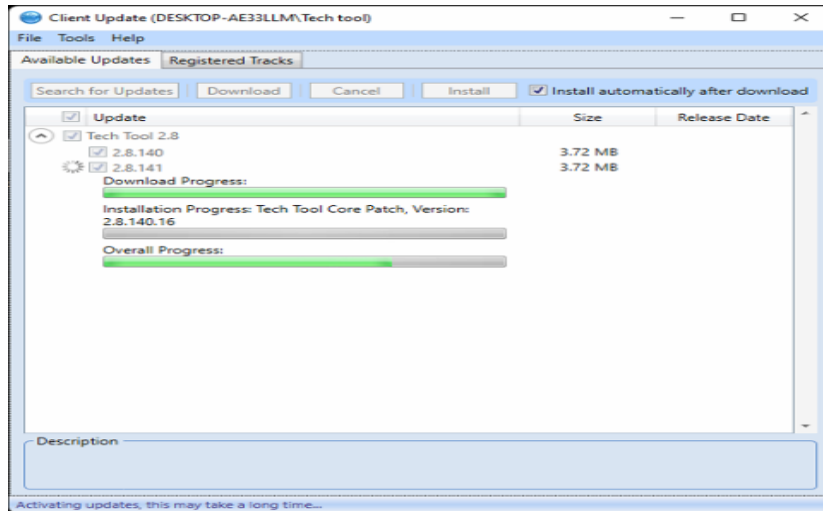
Issue-1: Tech Tool installation progress bar is frozen during Client Update.

Cause: Under Investigation.

Suggestion: Restart computer if the progress bar is frozen.

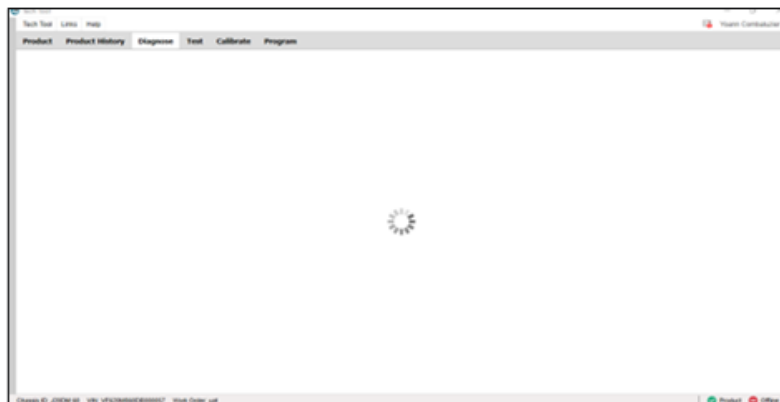
Issue-2: While switching between the tabs, the Tech Tool may experience a delay, which could cause it to freeze or display an error pop-up.

Cause: Under Investigation.

Suggestion: Kindly follow the below steps:

1. Ensure that there is a stable network as shown in the icon
2. Restart Tech Tool.
3. If not able to recover, restart the computer.

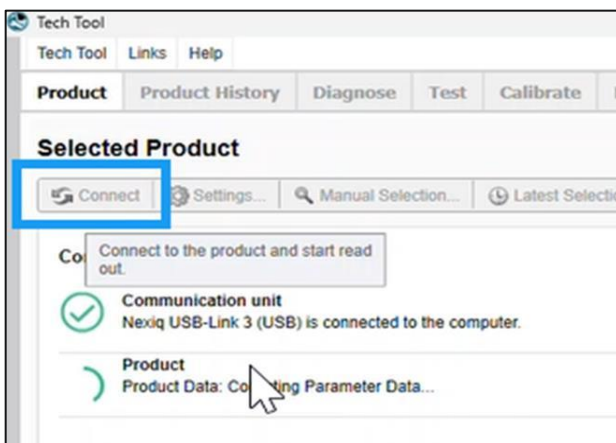
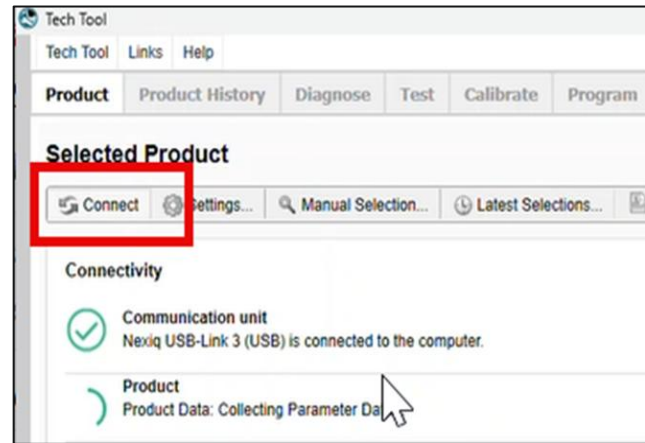
Issue-4: The product intermittently disconnects and reconnects during the identification process.

Cause: No impact on system functionality. User interface enhancement required

Suggestion: No workaround needed.

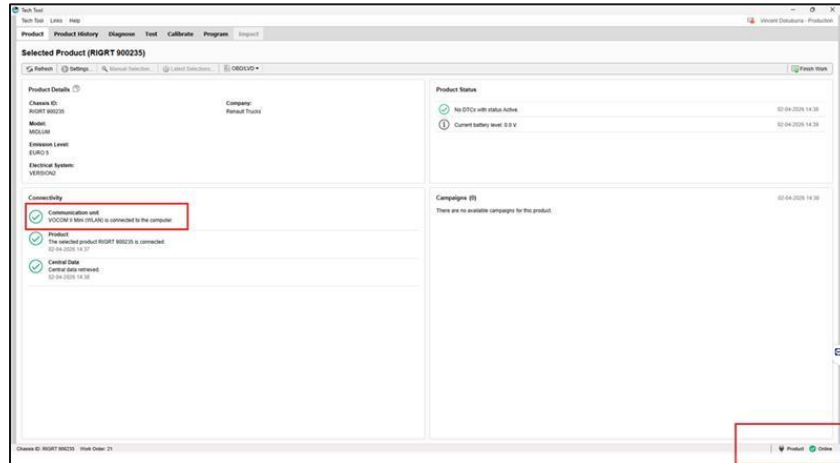
Issue-5: The connection status is intermittently not displayed correctly in the bottom-right corner after product identification

Cause: No impact on system functionality. User interface enhancement required

Suggestion: No workaround needed.

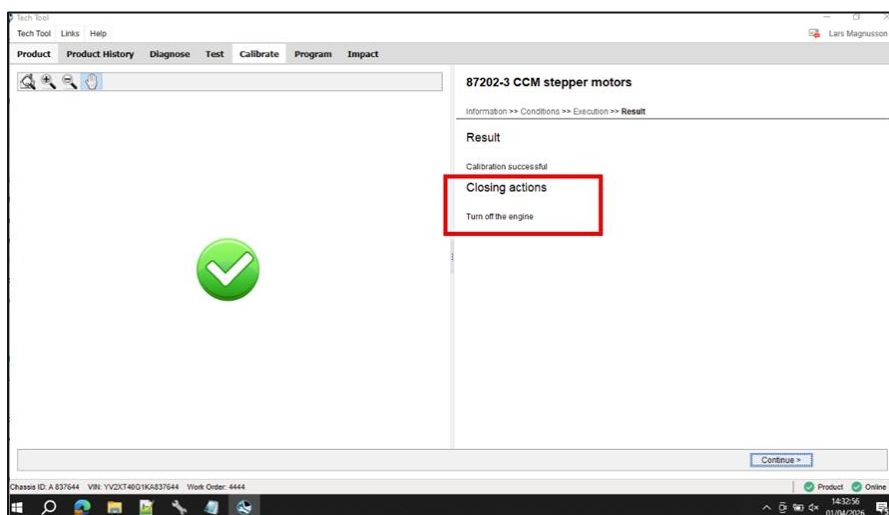
Issue-6: Incorrect closing instruction in the operation procedure for 87202-3 CCM stepper motors.

Cause: Incorrect instruction is available in closing action, however this action is not required to perform.

Suggestion: No action required; the engine will not be running.

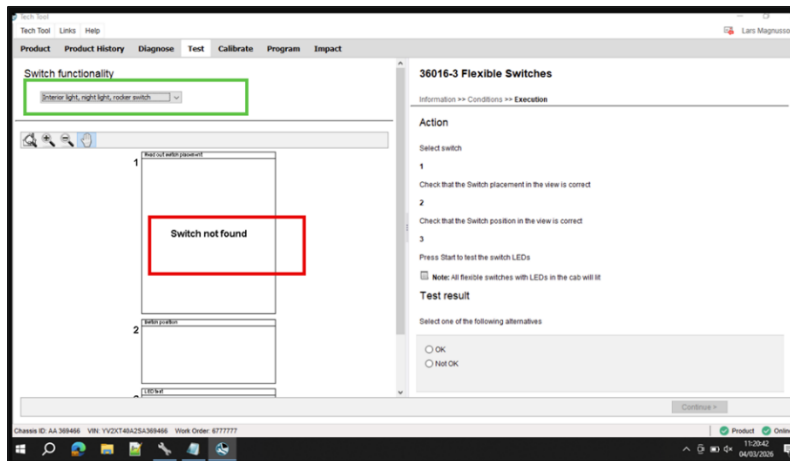
Issue-7: The switch location illustration is missing in Operation 36016-3 for Flexible Switches.

Cause: Under Investigation

Suggestion: Please refer the Impact to know the location of the flexible switch
