Date: 26 May 2026

TECH TOOL RELEASE NOTES

Version 2.8.380

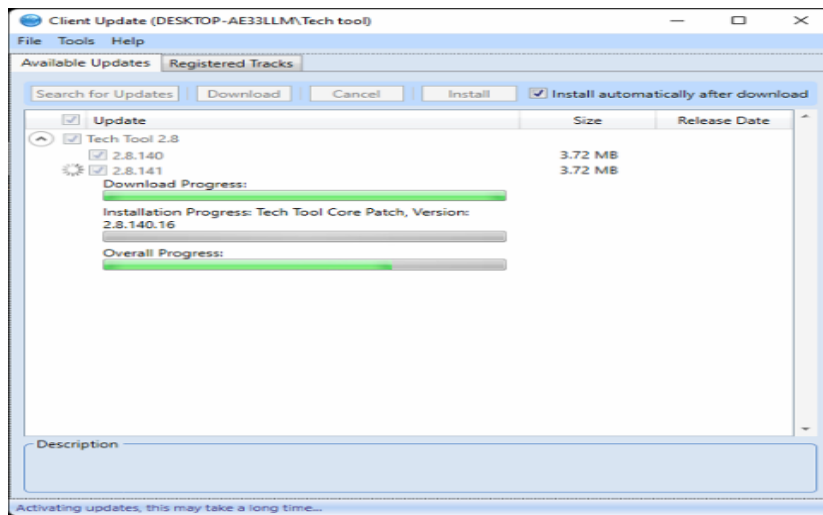
Issue-1: Tech Tool installation progress bar is frozen during Client Update.

Cause: Under Investigation.

Suggestion: Restart computer if the progress bar is frozen.

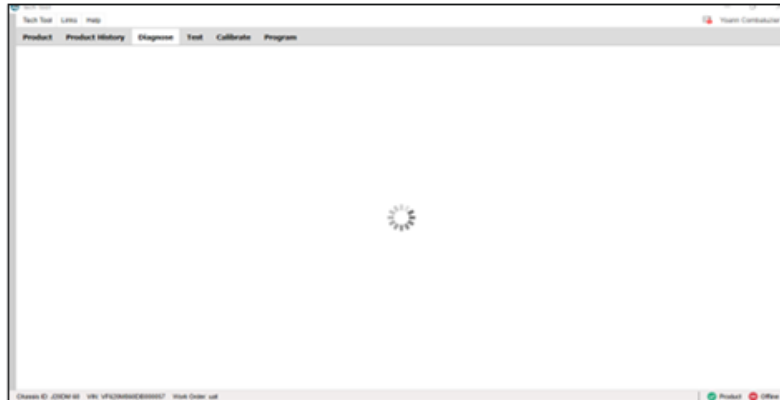
Issue-2: While switching between the tabs, the Tech Tool may experience a delay, which could cause it to freeze or display an error pop-up.

Cause: Under Investigation.

Suggestion: Kindly follow the below steps:

1. Ensure that there is a stable network as shown in the icon
2. Restart Tech Tool.
3. If not able to recover, restart the computer.
