Date: 13 August 2025

TECH TOOL RELEASE NOTES

Version 2.8.340

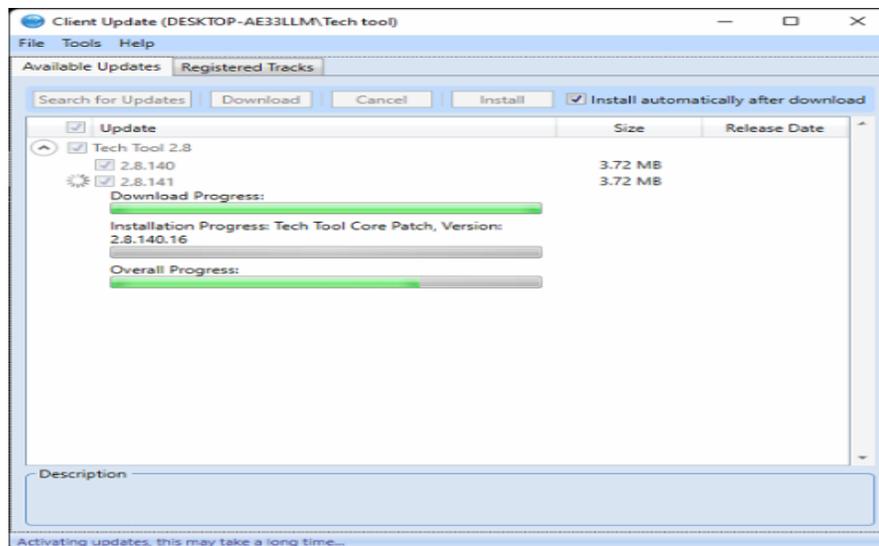
Issue-1: Tech Tool installation progress bar is frozen during Client Update.

Cause: Under Investigation.

Suggestion: Restart computer if the progress bar is frozen.

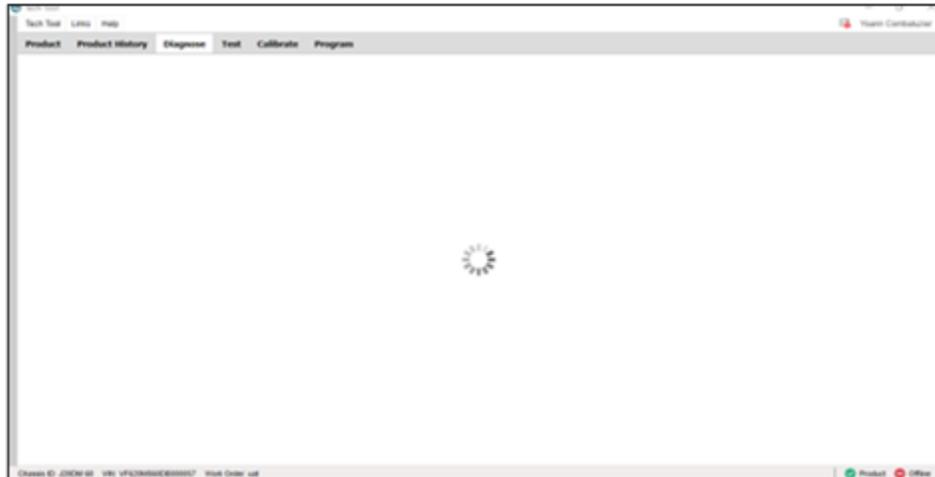
Issue-2: While switching between the tabs, Tech Tool might be frozen.

Cause: Under Investigation.

Suggestion: Kindly follow the below steps:

1. Ensure that there is a stable network as shown in the icon

2. Restart Tech Tool.
3. If not able to recover, restart the computer.
